Pentium® II Xeon™ Processor Specification Update

Release Date: August 1999

Order Number: 243776-015

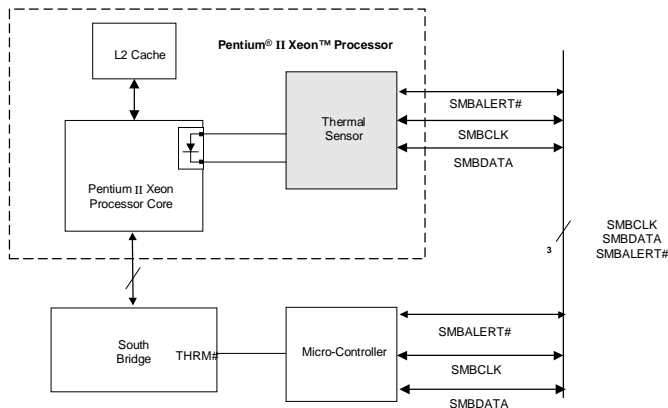
Figure 1. An Example of Microcontroller Driven Thermal Management

D30. Thermal Sensor May Assert SMBALERT# Incorrectly

PROBLEM: The Pentium II Xeon processor has a thermal sensor that monitors the processor core's temperature. The thermal sensor asserts SMBALERT# if the processor temperature exceeds the temperature limits set in the Alarm Threshold Registers (T_{HIGH} , T_{LOW}). It also sets the corresponding Status Register bits to identify the cause of the interrupt. Figure 1 gives one example of the how the SMBALERT# signal could be used in a system.

Under the conditions described below, the thermal sensor incorrectly generates the SMBALERT# interrupt. *All* of the following conditions must be met to trigger a false interrupt:

WORKAROUND: Three different (mutually exclusive) workarounds are possible:

1. Before servicing an interrupt from the thermal sensor, read and compare the processor thermal reading with the threshold limits (T_{HIGH} or T_{LOW}). Figures 2 and 3 provide basic flowcharts for the implementation of this workaround in an interrupt driven system.
2. If the firmware implemented polls the Status Register only, then before taking any action, re-read the temperature register and do a comparison with the alarm threshold limits (T_{HIGH} or T_{LOW}) to determine if the value is actually still within the temperature window.
3. Use a temperature polling scheme to monitor the processor temperature.
